# PROJECT REPORT

LIHUE PUHI | AUGER SCREENS | 2024

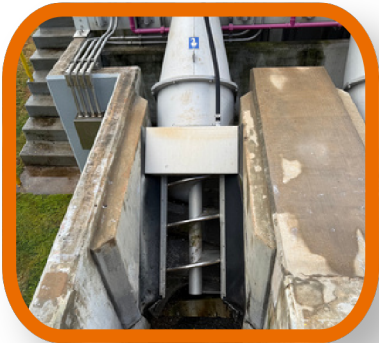
- Installed two Huber Micro Strainer ROTAMAT® Ro9 Screw Screens: one to replace the aging unit and one to provide full-capacity redundancy.
- Combined screening, conveying, washing, dewatering and compaction in one compact system.
- Used a single-drive design to reduce mechanical complexity and maintenance requirements.
- Added self-cleaning operation to support consistent performance with less operator intervention.
- Washed and compacted screenings to reduce waste volume and weight before disposal.
